# Briefing on E2 Anchor Bolts – May 8, 2013

THE SAN FRANCISCO-OAKLAND  
**BAY BRIDGE**  
SEISMIC SAFETY PROJECT

# Four Key Questions

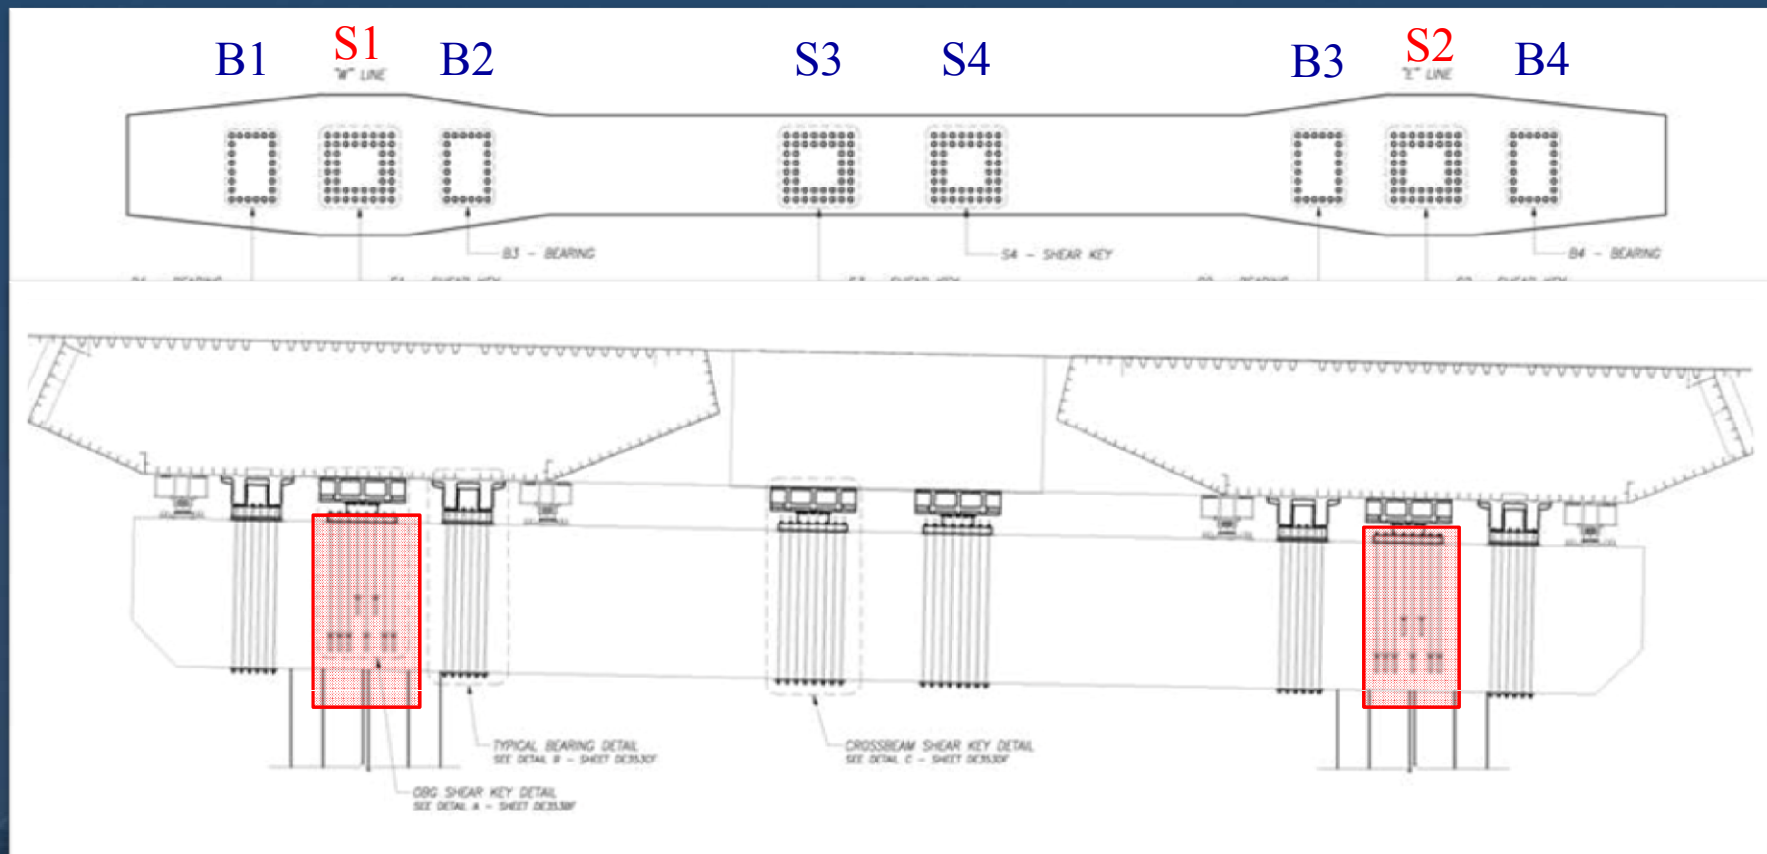
- Bearings and shear keys are secured to E2 by 3 inch diameter bolts, ranging from 9 feet to 24 feet in length and to the OBG by 2 to 3 inch diameter bolts ranging 2 to 5 feet in length.
- 96 bolts manufactured in 2008 shown in red are embedded in the pier..

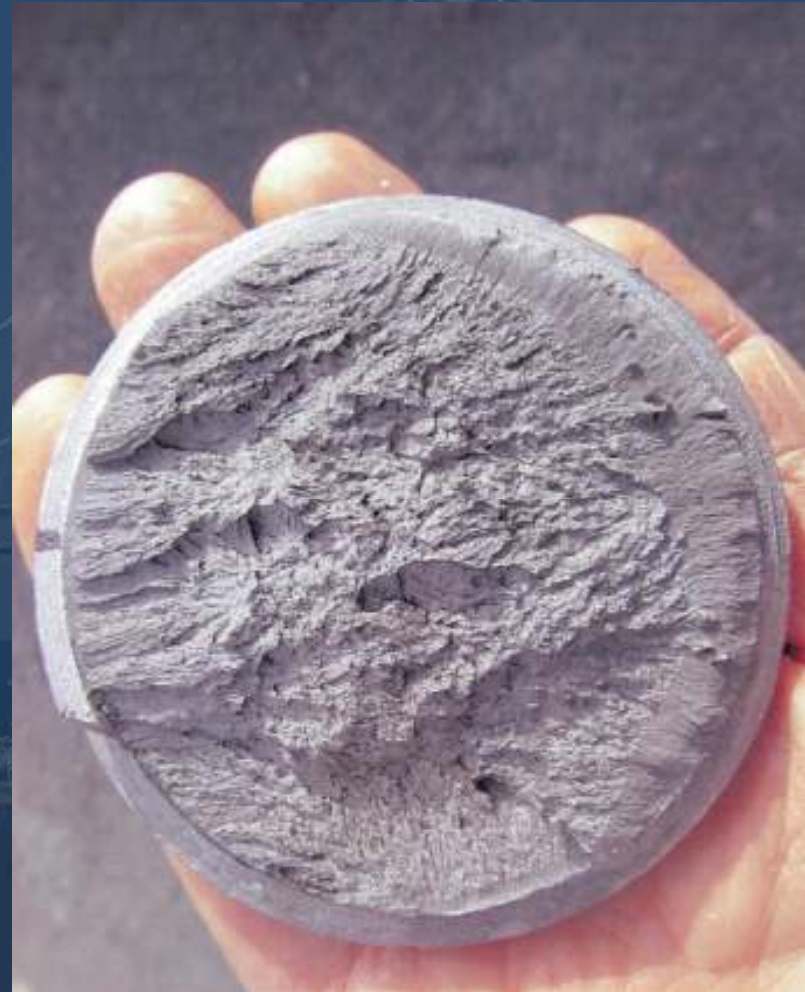
- Under detailed investigation by Caltrans and the Contractor, 2008 bolt failures are due to hydrogen embrittlement.
- Excess hydrogen in the 2008 bolts caused the threaded areas of bolts to become brittle and fracture under high tension.

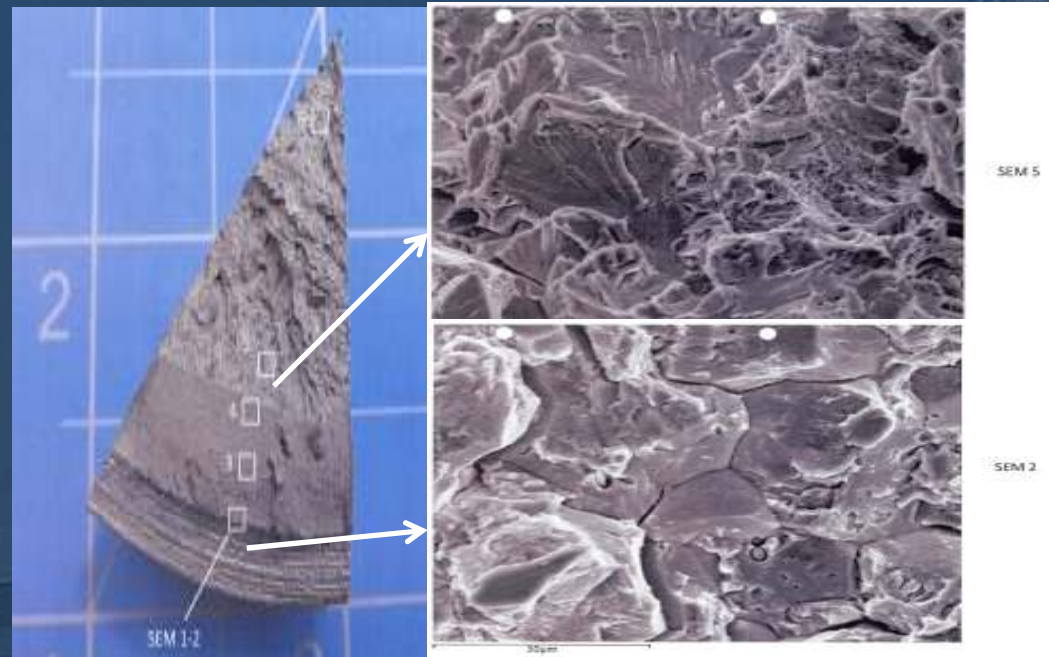
1000X Magnification

- Metallurgical analysis indicates 2008 bolts were susceptible to hydrogen embrittlement due to “a lack of uniformity in the microstructure of the steel.”

- **Additional supplementary requirements designed to ensure selection of high quality, high hardenability steel that can be heat treated and galvanized to provide bolts with an optimal combination of strength, toughness and uniform microstructure through the entire cross section.**

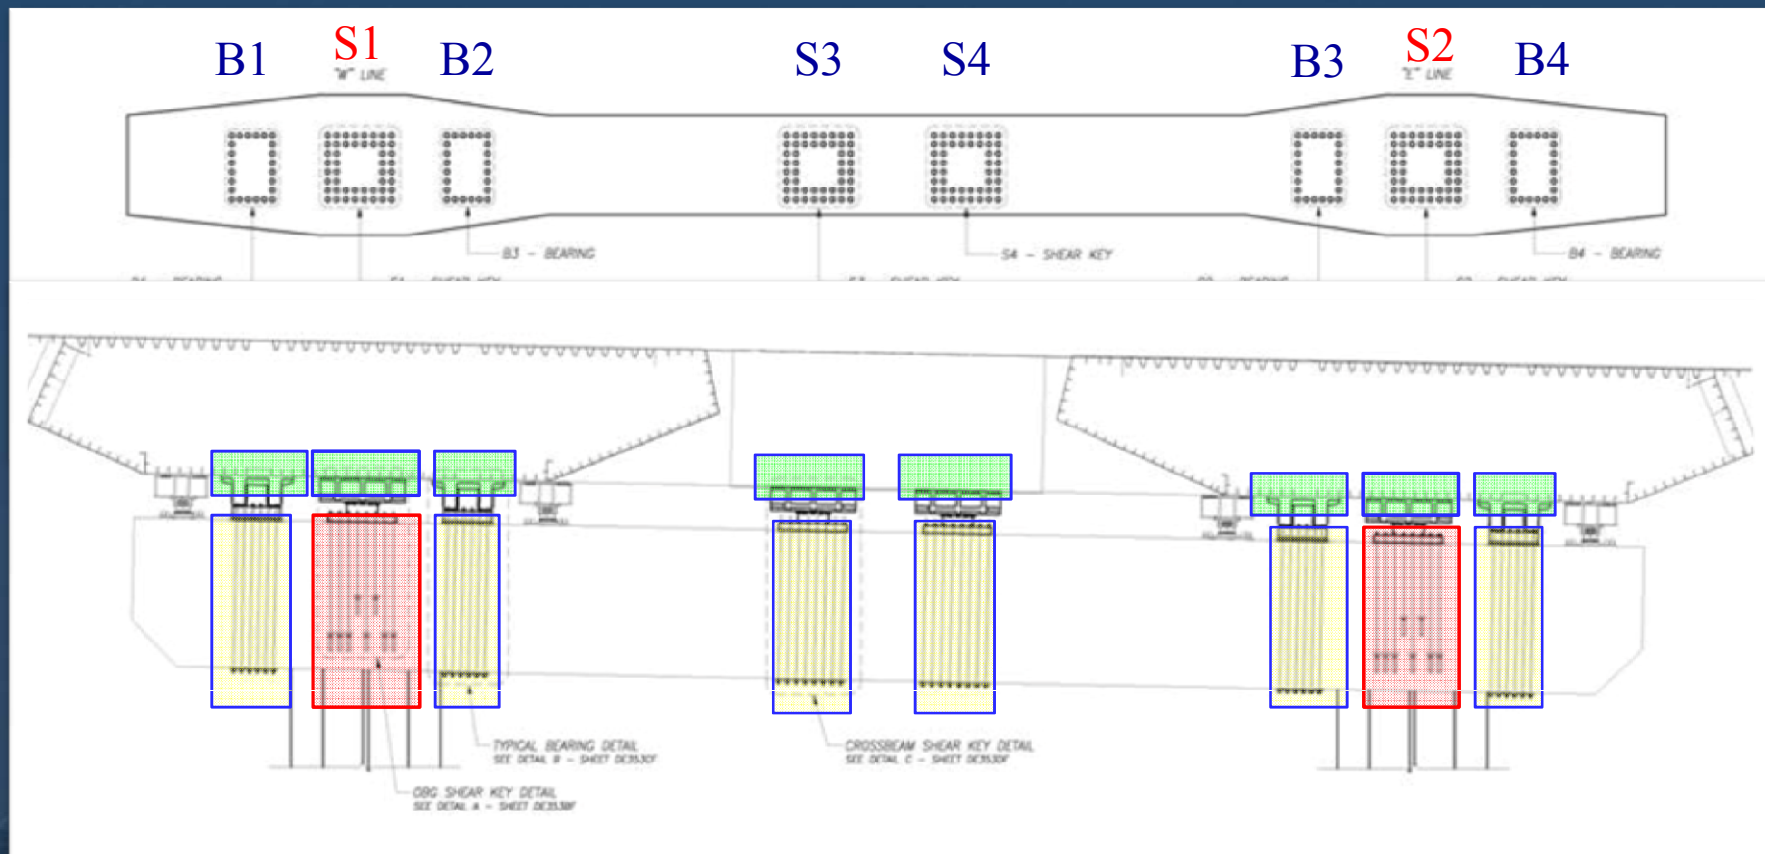
- 96 bolts manufactured in 2008 shown in red are embedded in the pier.
- 192 bolts manufactured in 2010 shown in blue are not embedded in pier.
- 544 bolts manufactured in 2010 shown in green are connected to the OBG.
- There are an additional 432 bolts of 1 inch diameter, varying from 2 inches to 2 feet in length, that are internal to the E2 bearing assembly.

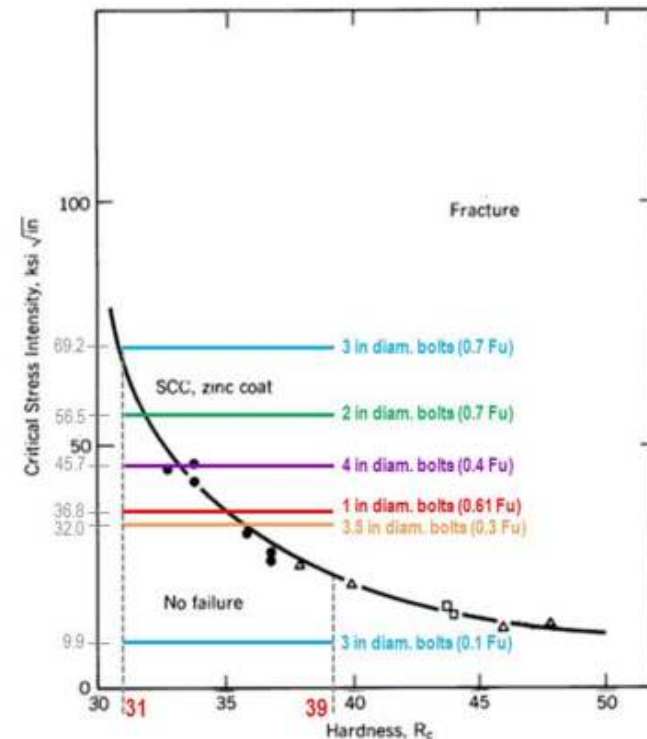
- Long term stress corrosion susceptibility is a function of the size and harness of material, and level of tensioning.
- Staff will be evaluating the high-strength bolts used on the project to determine if additional remedial action is needed.

Fig 4.28. Critical Stress intensities in presence of corrosive environment;  
●  $K_{sc}$ , hot-dip Al-Zn; ▲  $K_{sc}$ , electroplated zinc; ■  $K_{sc}$ , hot-dip zinc.

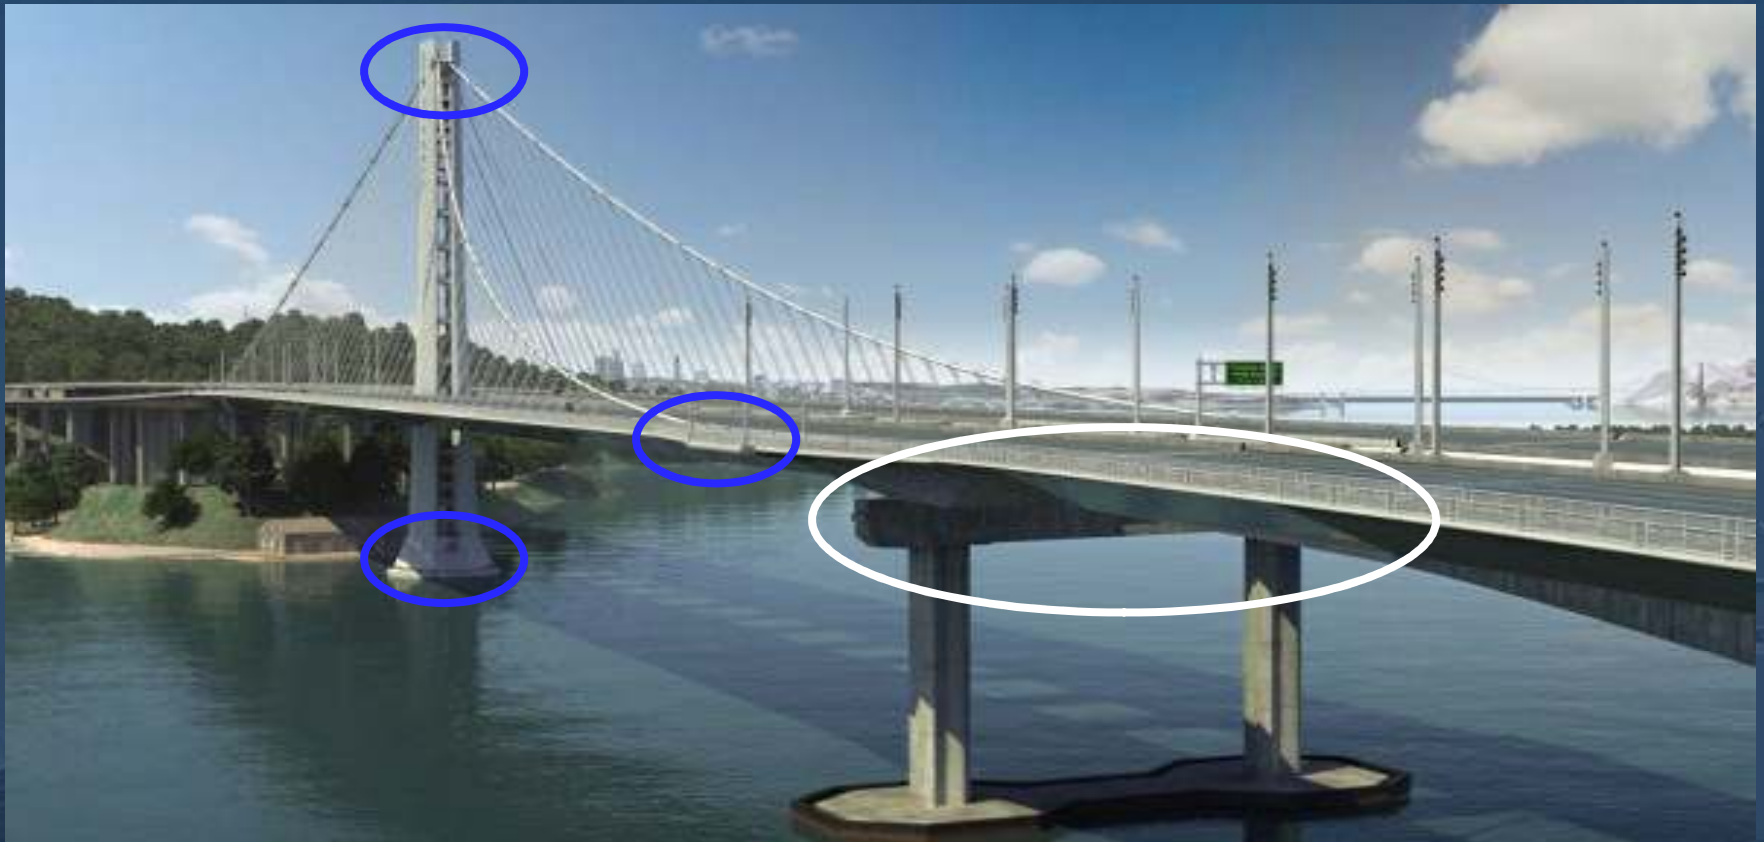
- **Visual inspections of similar anchor bolts revealed they are performing as required.**
- **Some E2 Bearing assembly bolts are not accessible to inspection.**
- **Most anchor bolts at other locations are under lower tension levels.**
